Stearns® Spring-Set Disc Brakes

Installation and Service Instructions for 1-056-700 Series (rev. C) Double C-Face Coupler

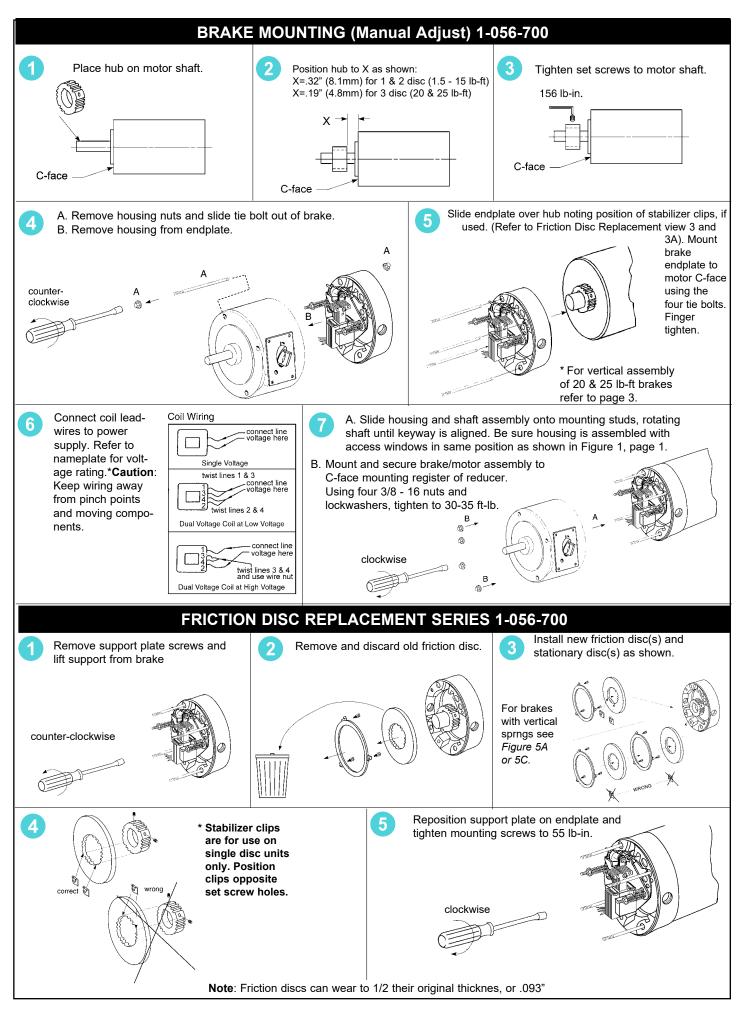
AIR GAP ADJUSTMENT 1-056-700

As friction disc wear the air gap will increase. When plunger gets to the reset position, the air gap must be adjusted.
